# Tree Survey and Arborist Report for TR38237

*an Approximate 9.4-acre Site on the NE C/O Oliver St. and Brodiaea Ave.*

*In the City of Moreno Valley, County of Riverside, California*

*Report Date: July 11, 2022*

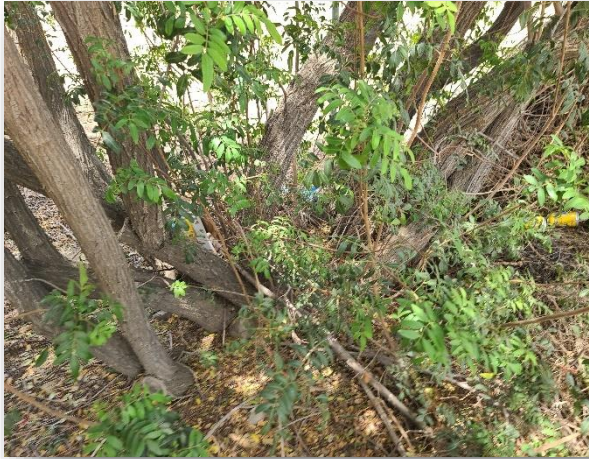
Plate 1. This is a view of a multi- stem configuration (#358).

| Tree Tag # | Species <sup>1</sup> | DBH (inches) | | | | | | | Height (feet) | Canopy Width (feet) | Gen Area | Env | Risk | Conclusion | Heritage |
|---|---|---|---|---|---|---|---|---|---|---|---|---|---|---|---|
| Good vigor, Poor scaffolding, appears to be in ROW | | | | | | | | | | 10 | | 10 | | | |

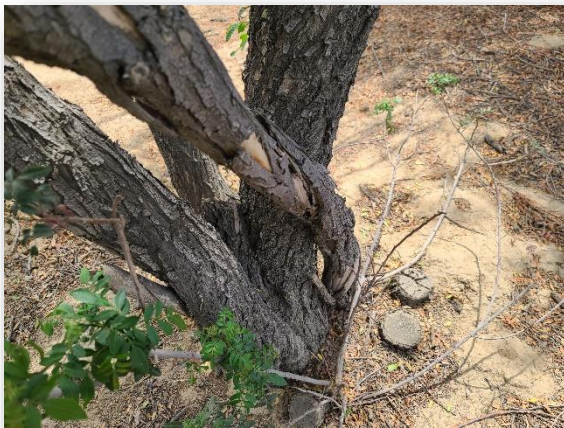
Plate 3. This is a view of a dead, diseased limb (#361).

| Tree Tag # | Species <sup>1</sup> | DBH (inches) | | | | | | | Height (feet) | Canopy Width (feet) | Gen Area | Env | Risk | Conclusion | Heritage |
|---|---|---|---|---|---|---|---|---|---|---|---|---|---|---|---|
| Decline, Poor prognosis, appears to be in ROW | | | | | | | | | | 6 | | 6 | | | |

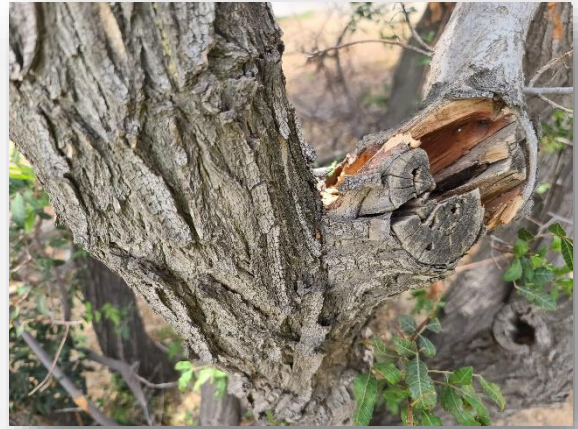
Plate 6. This is a view of bore holes within a branch cut (#365).

| Tree Tag # | Species <sup>1</sup> | DBH (inches) | | | | | | | Height (feet) | Canopy Width (feet) | Gen Area | Env | Risk | Conclusion | Heritage |
|---|---|---|---|---|---|---|---|---|---|---|---|---|---|---|---|
| Diseased limbs, Borers, appears to be in ROW | | | | | | | | | | 14 | | 6 | | | |

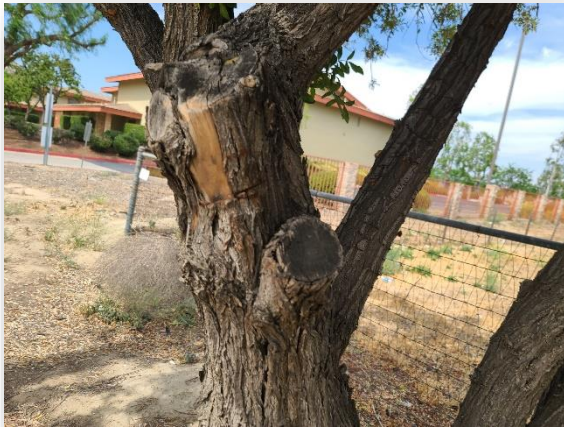
Plate 7. This is a view of diseased wood resulting from poor pruning (#376).

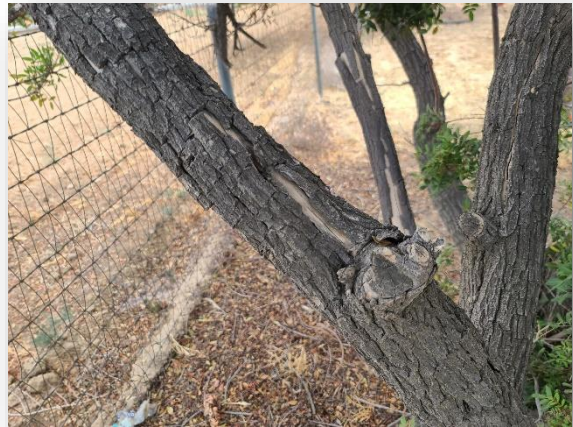
Plate 8. This is a view of diseased tissue on a primary stem (#368).

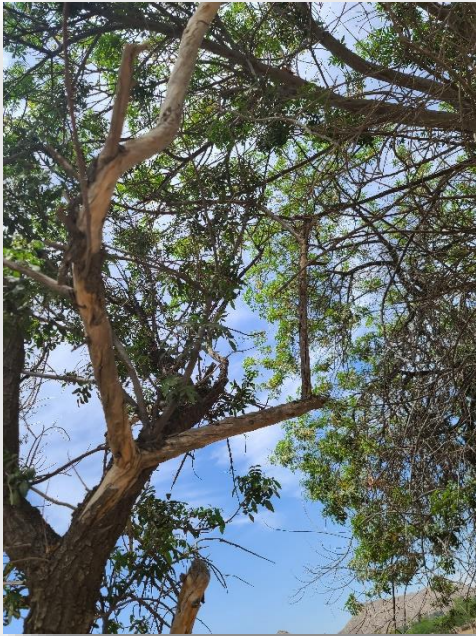
Plate 9. This is a view of a diseased limb within a canopy (#361).

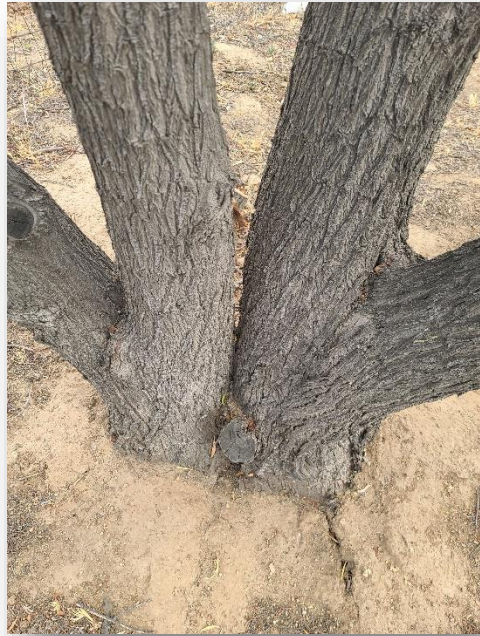
Plate 10. This is a view of included bark within the crotch of two primary stems (#372).

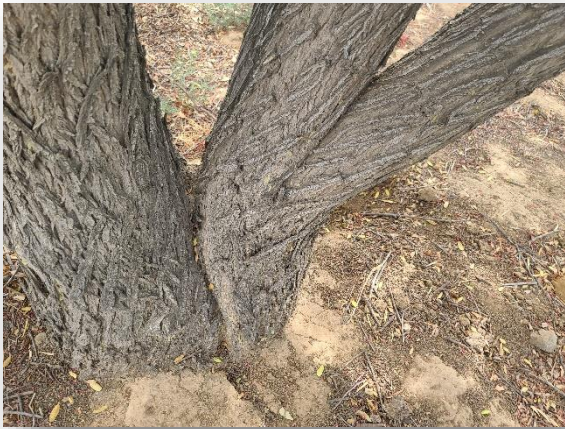
Plate 11. This is view of included bark within the crotch of a primary stem and limb (#369).
